October 26, 2001

KL&J Management
Park Tower Apartments
280 Island Avenue
Reno, Nevada 89501

Re: Due Diligence Report for Property at
Park Tower Apartments
280 Island Avenue
Reno, Nevada

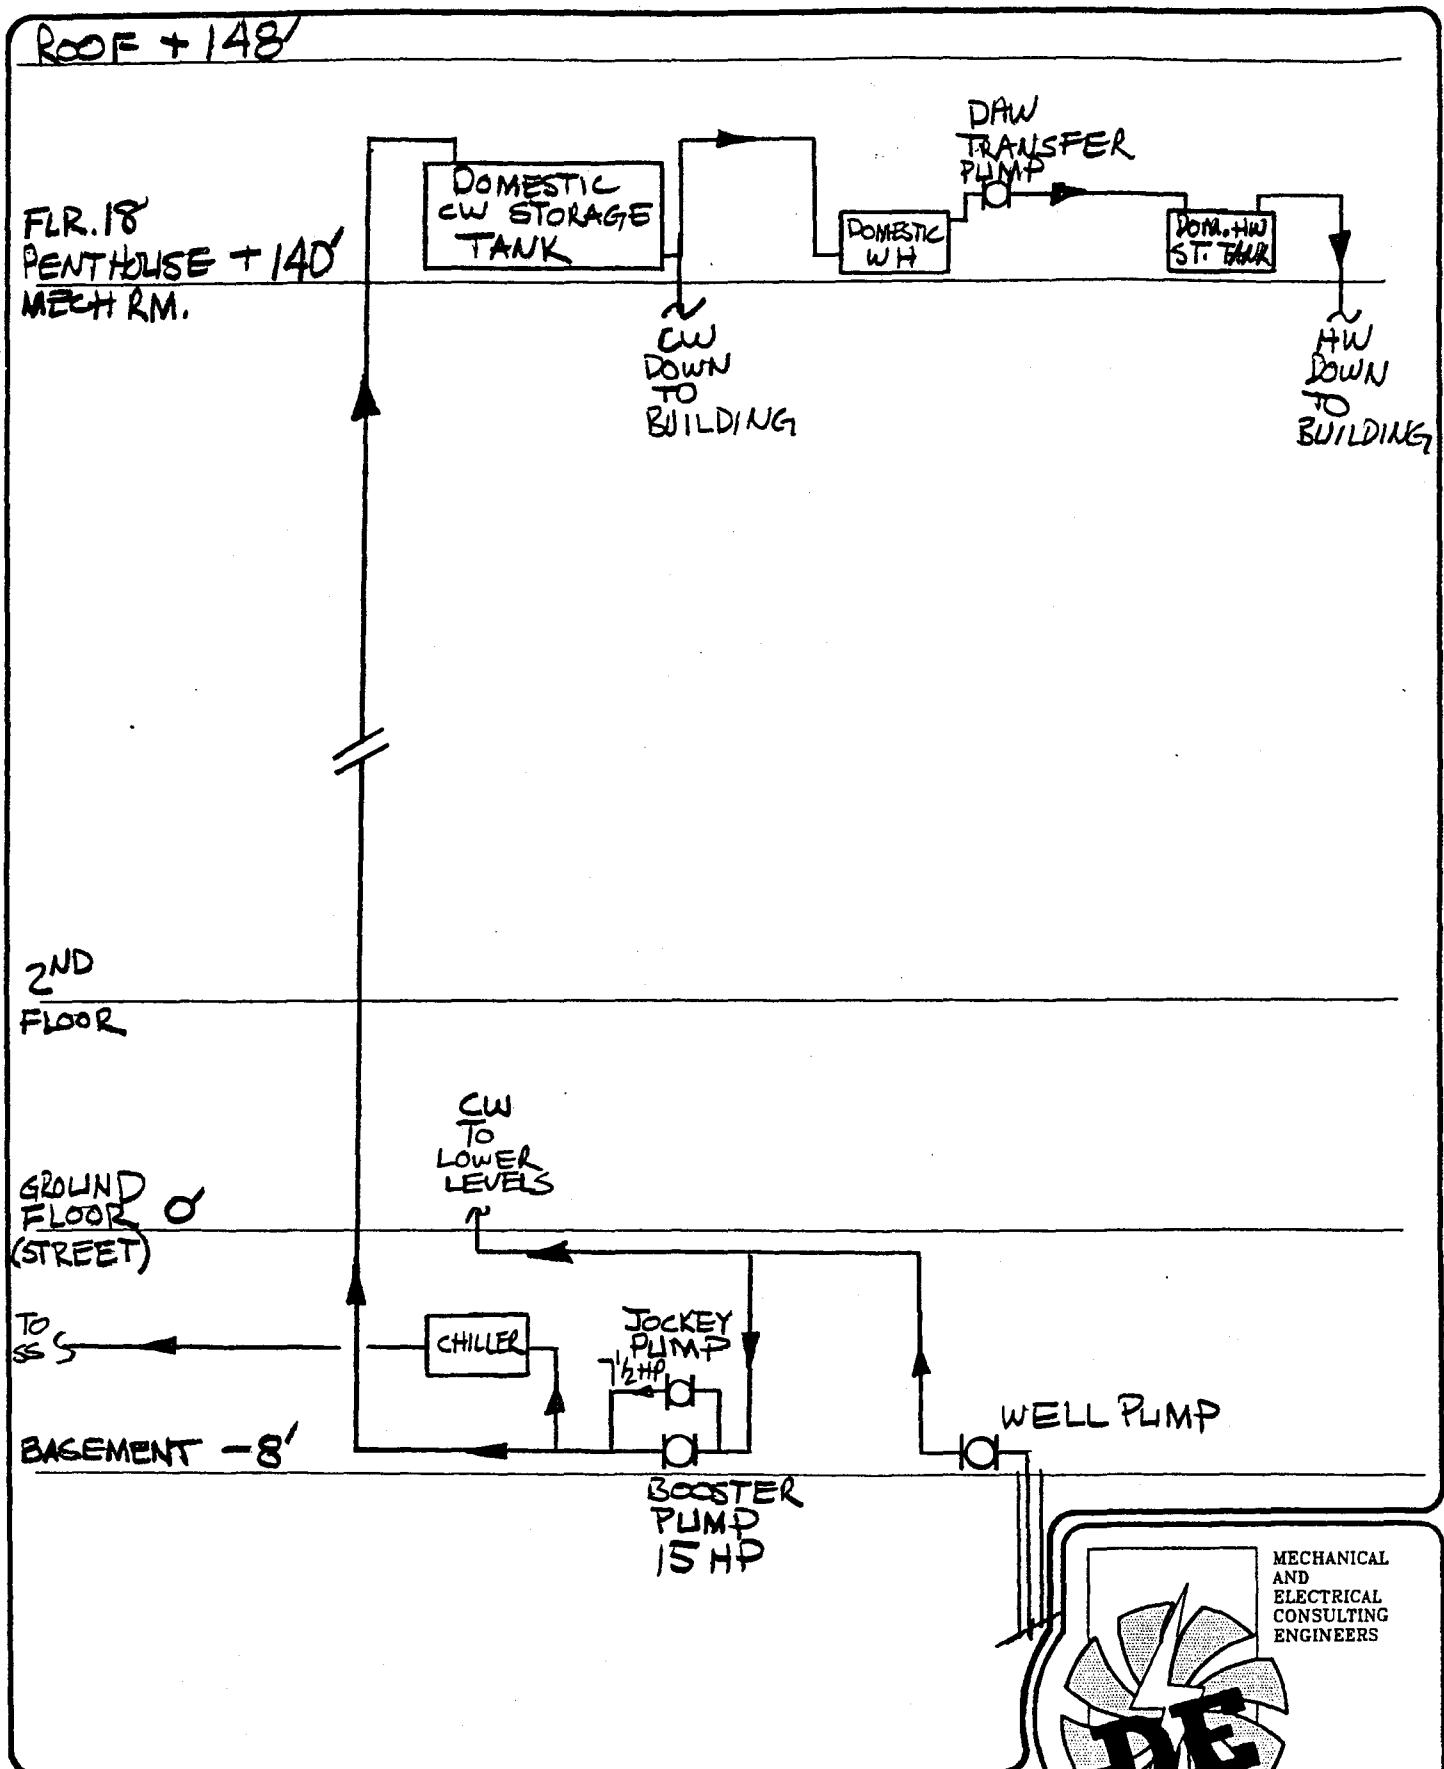
TITLE: DOMESTIC WATER SYSTEM
 SHEET NO.: P-1 OF 1
 JOB NAME: PARK TOWERS APTS.
 CALCULATED BY: TPF DATE: 3-19-01
 CHECKED BY: _____ DATE: _____

Attached is a rough schematic diagram showing the existing domestic water system for this facility. The existing well has been abandoned, and new domestic and fire water services have been provided from the Truckee Meadows Water Authority's (TMWA) system, with all associated back flow prevention for each service. TMWA is the new water system provider composed of the City of Reno, City of Sparks, and Washoe

County which purchased the water system from Sierra Pacific Power Company (SPPCo). The new water services enter the building in the basement and connect to the existing distribution system piping in the basement level ahead of the existing pressure booster.

As shown on the attached piping schematic diagram, the existing booster system for the domestic water consists of a primary 15-Hp pump, and a 7½-Hp jockey pump which takes water from the well discharge piping and discharges to a storage tank located on the 18th floor. Name plate data from the existing booster pump was recorded, and a pump curve for this pump was obtained (see pump curve attached herein). The primary pressure booster is a base mounted, centrifugal, end-suction pump, which is powered by a 15-Hp motor operating at 3500 rpm. Indications from the name plate are that the impeller trim fitted is a 6¾" diameter impeller. This agrees with the pump curve data shown as the 6¾" diameter impeller is non-overloading over the entire pump curve with a 15-Hp motor installed. With the new domestic water service from TMWA connected to the existing piping, the existing distribution and pressure booster systems operate in the same manner as the previous operation. That is, incoming water for domestic service is boosted in pressure from a separate pump, and pumped up through the building to a storage tank located in the penthouse mechanical room. Domestic hot water for the entire building is also generated in the penthouse mechanical room through a hot water coil, which is fed from the primary heating system boilers, in a separate storage tank.

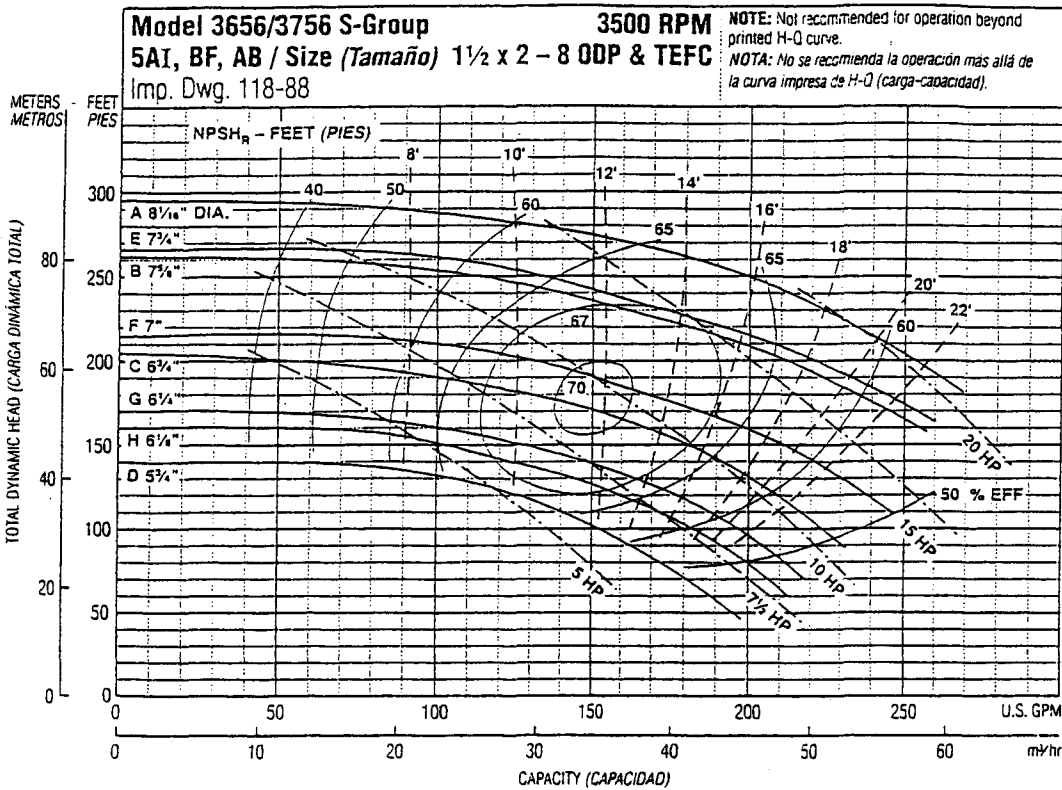
*Installed pump @
 Park Towers Apts., Reno*
